SUPPORT SERVICE BULLETIN

VIQ Support Services – June 20, 2007

RecordIAB Maintenance History

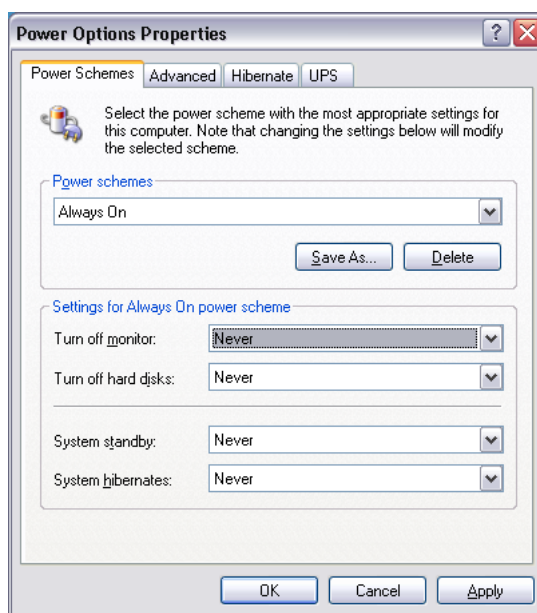
- **RecordIAB v 2.5 Console LCD “Freezes”**

Some customers have set or have used a Power Scheme that sets the Power Options found in the Control Panel to “Power Off the Monitor after 20 minutes” or more. This turns off the built-in LCD panel including the touchscreen which can not be reactivated. The Power Options must all be set to “NEVER.”

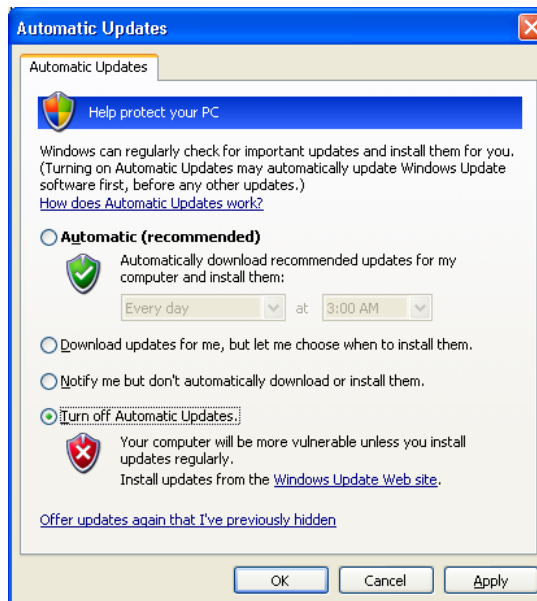
- **RecordIAB v. 2.5 Windows Automatic Updates**

To avoid any software conflicts between Windows updates and the RecordIAB software, please ensure that the Windows Automatic Update settings are set to “Turn off Automatic Updates.”
